**Flood Control Project Maintenance
Levee Inspections**

Maintenance Issue Types Only, Levee Inspection Report By Mile - Fall 2016

Reclamation District No. 0755 Randall

Waterway	Bank	Unit Miles	Inspection Start/End	Inspector
Unit No. 01 Sacramento River	Left	1.83	10/18/2016 10/18/2016	Herman Phillips

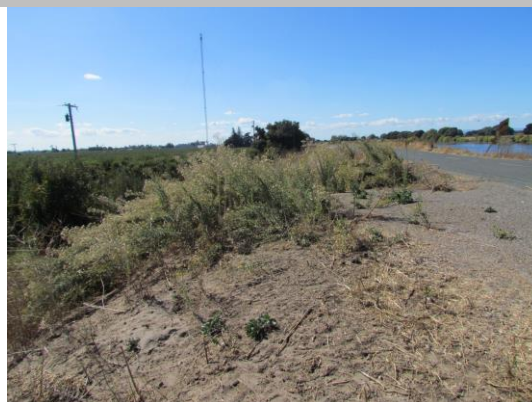
Photo 1 of 1 : FA_2016_RD0755_177_22_20161102_00030.jpg

LM Start	0.59	Rating **	U	Issue No.	22
LM End	0.61	Issue Type +	Ma	Location *	LS
Category	Earthen Levee			GPS Latitude/Longitude	
				Start	End
Item	Vegetation			38.345423 °	38.345375 °
				-121.546223 °	-121.546543 °
DWR ID	DWR_RD0755_01_f_2016_22				
Comment Code					
V1 : Control annual grass and weeds on the levee slopes and easements.					
Inspector Comment					
Remove the tall weed growth from the levee slope and ramp of the landside levee section.

RD 755 looking downstream from landside levee mile 0.59-0.61.
